Rochester Community and Technical College

Comprehensive Facilities Plan

Volume 1 100% Submittal

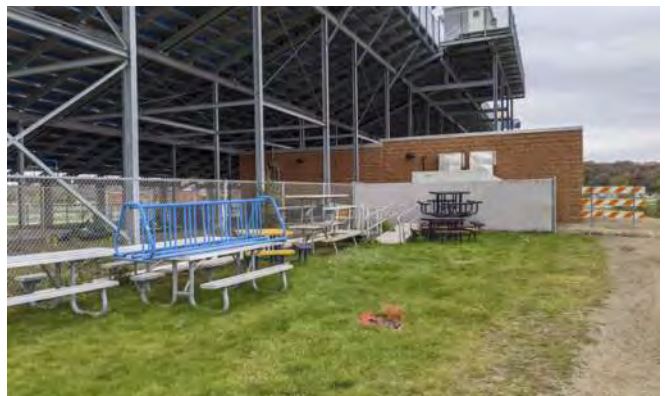
Site Furnishing Storage Behind Stadium

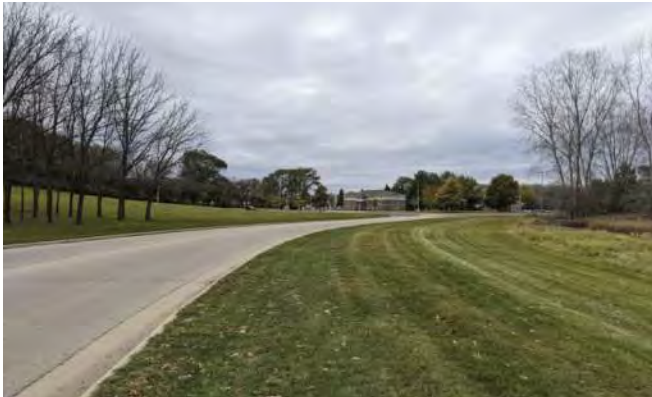
Overall, pedestrian circulation is focused on bringing people from the parking lot to the campus buildings but often falls short within the parking lot. Focused improvements need to occur to enhance the experience of all users but especially those who park in the ADA spaces. The eastern lot is missing curb cuts to the adjacent sidewalk. The nearest ADA spaces in the north parking lot are located nearly 300-feet away from the Sports Center main doors. The western parking has great crosswalk connections through the parking lot but the paved lot with no landscaping provides a stark experience as you walk to the Main Building. Campus-wide there are many areas not fully up to ADA code with ramps missing or outdated.

Pedestrian Connection Missing Along College Parkway

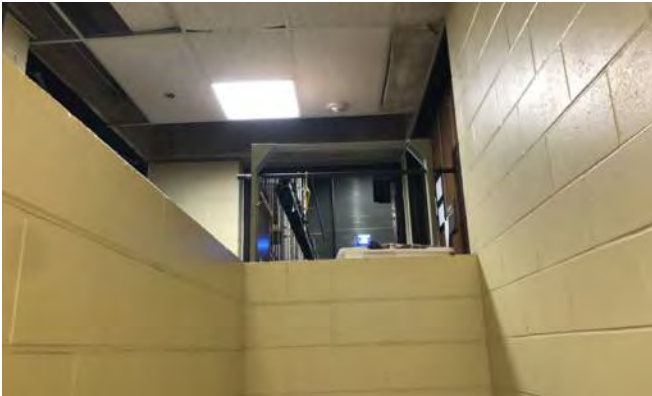
Damaged acoustical ceiling
